# PRESIDENTIAL COMMISSION

*on the Space Shuttle  
Challenger Accident*

Presidential Commission  
on the  
Space Shuttle Challenger Accident

June 6, 1986

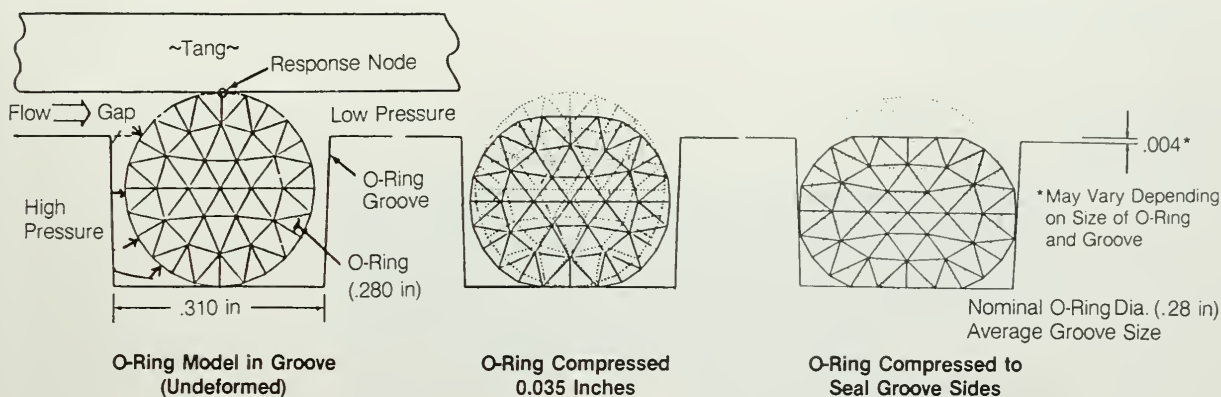
Figure 18  
 Drawings show how progressive reduction of gap between tang and clevis can inhibit and eventually block motor cavity's high-pressure flow from getting behind O-ring.

Recent analysis has shown and tests tend to confirm that O-ring sealing performance is significantly improved when actuating pressure can get behind the entire face of the O-ring on the upstream side of the groove within which the O-ring sits (Figure 18). If the groove is too narrow or if the initial squeeze is so great as to compress the O-ring to the extent that it fills the entire groove and contacts all groove surfaces, pressure actuation of the seal could be inhibited. This latter condition is relieved as the joint gap opens and the O-ring attempts to return to its uncompressed shape. However, if the temperature is low, resiliency is severely reduced and the O-ring is very slow in returning towards its original shape. Thus, it may remain compressed in the

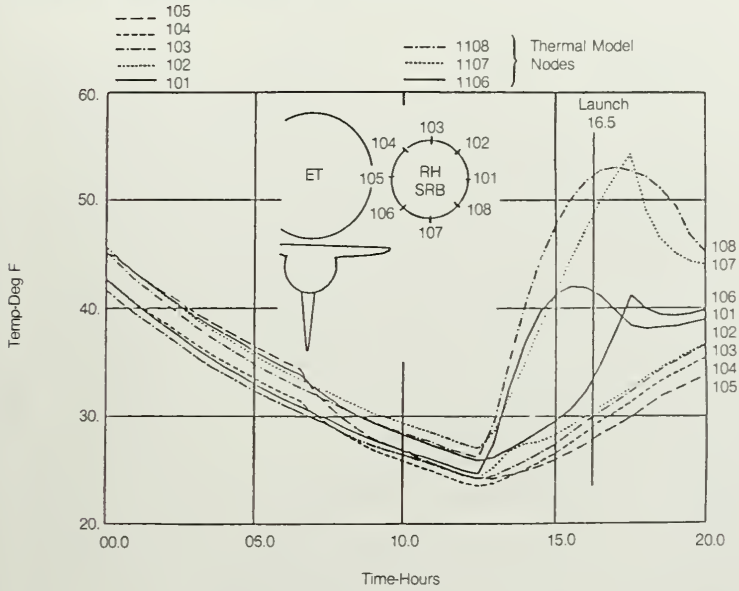
joint in Figures 20 and 21. These data are representative of other joints on the respective Solid Rocket Motors.

Figure 20  
Temperature model for 51-L right solid booster aft segment circumferential positions from 16.5 hours prior to launch to 3.5 hours after launch.

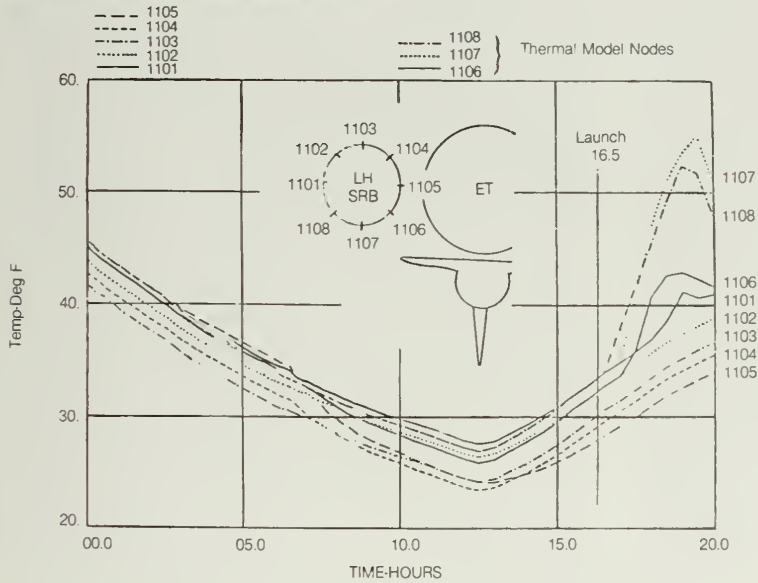
Figure 21  
Temperature model for 51-L left solid booster aft segment circumferential positions from 16.5 hours prior to launch until 3.5 hours after launch.

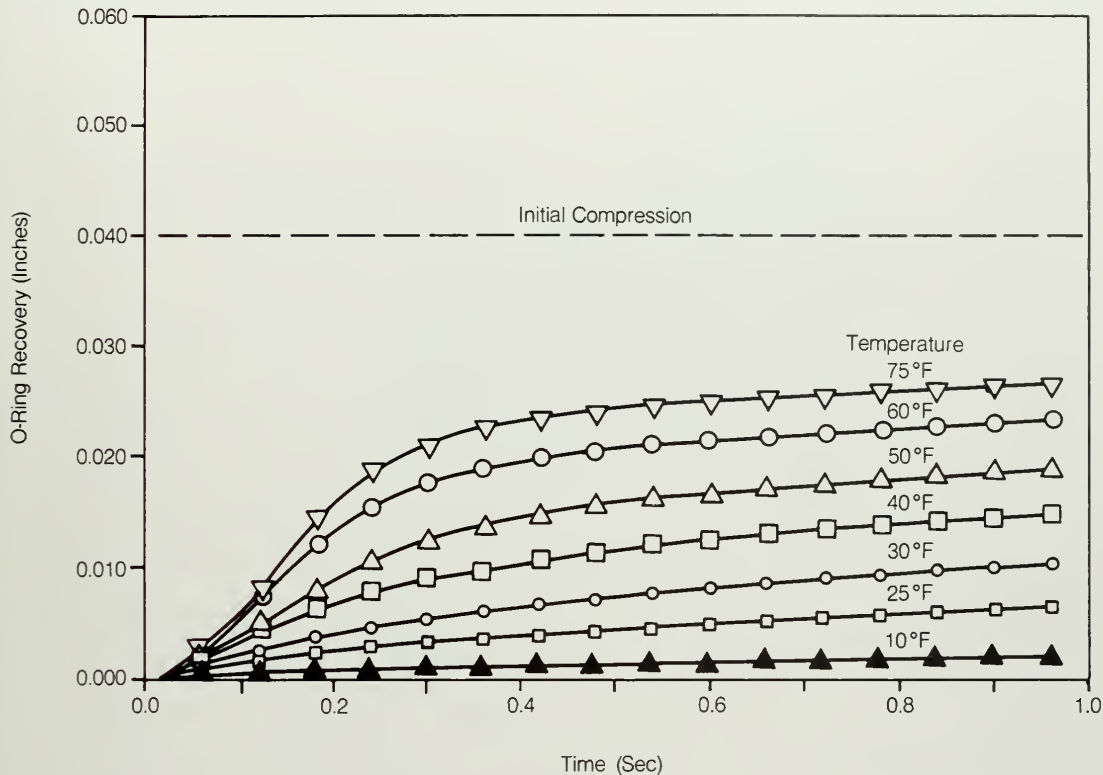
Consistent results from numerous O-ring tests have shown a resiliency degradation with reduced temperatures. Figure 23 provides O-ring recovery from 0.040 inches of initial compression versus time. This shows how quickly an O-ring will move back towards its uncompressed shape at temperatures ranging from 10 to 75 degrees Fahrenheit. When these data are compared with the gap openings versus time from Figure 17, it can be seen that the O-rings will not track or

Figure 23  
Graph plots O-ring shape recovery in inches against time in seconds for a variety of temperatures.

Note: Average O-Ring Recovery at Various Test Temperatures During First Second After Load Release. Initial Compression of 40 Mil Was Maintained for 2 Hours.

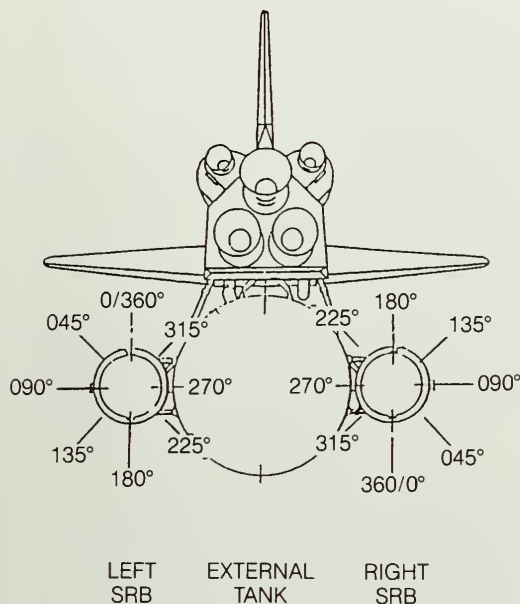
Figure 26

parts 131, the upper segment tang region, and part 712, the lower clevis region of the joint. This burned area extends roughly from station 1476, in the upper section, to 1517 on the lower region. In a circumferential direction (see figure 26) the lower end of the eroded region extends from roughly 291 degrees to 320 degrees and the upper eroded section extends between 296 and 318 degrees. Note that the region at about 314 degrees includes the attachment region of the strut to the attachment ring on the right Solid Rocket Booster.

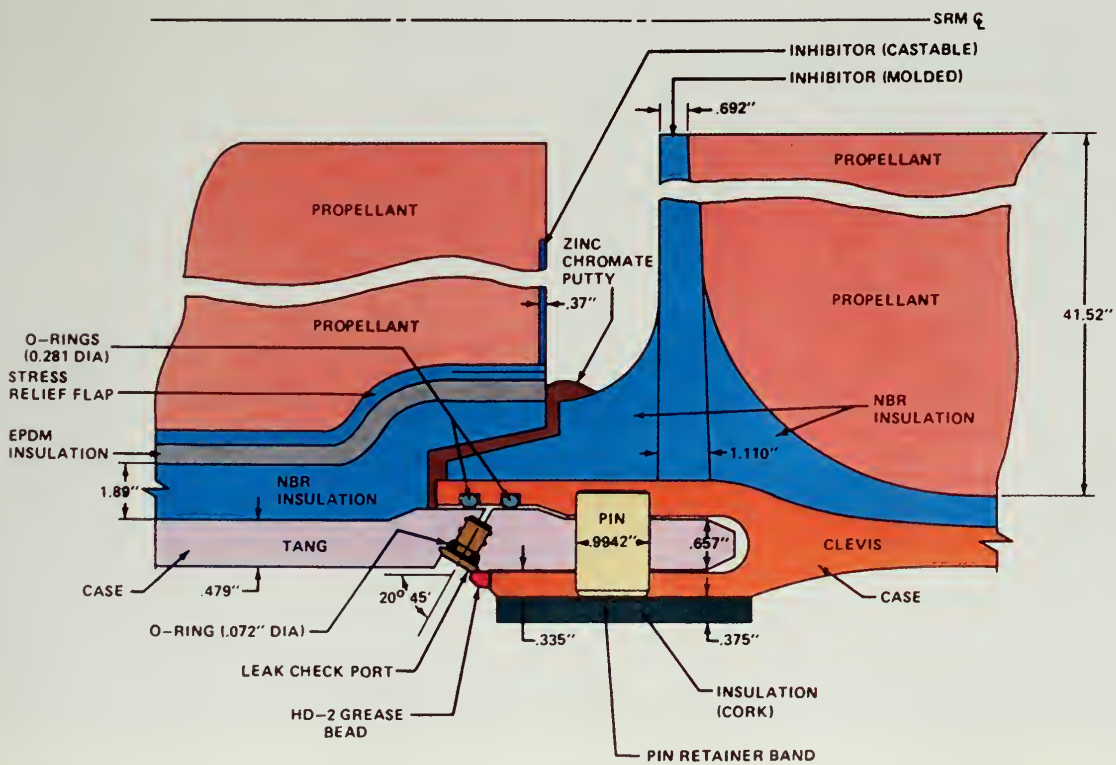
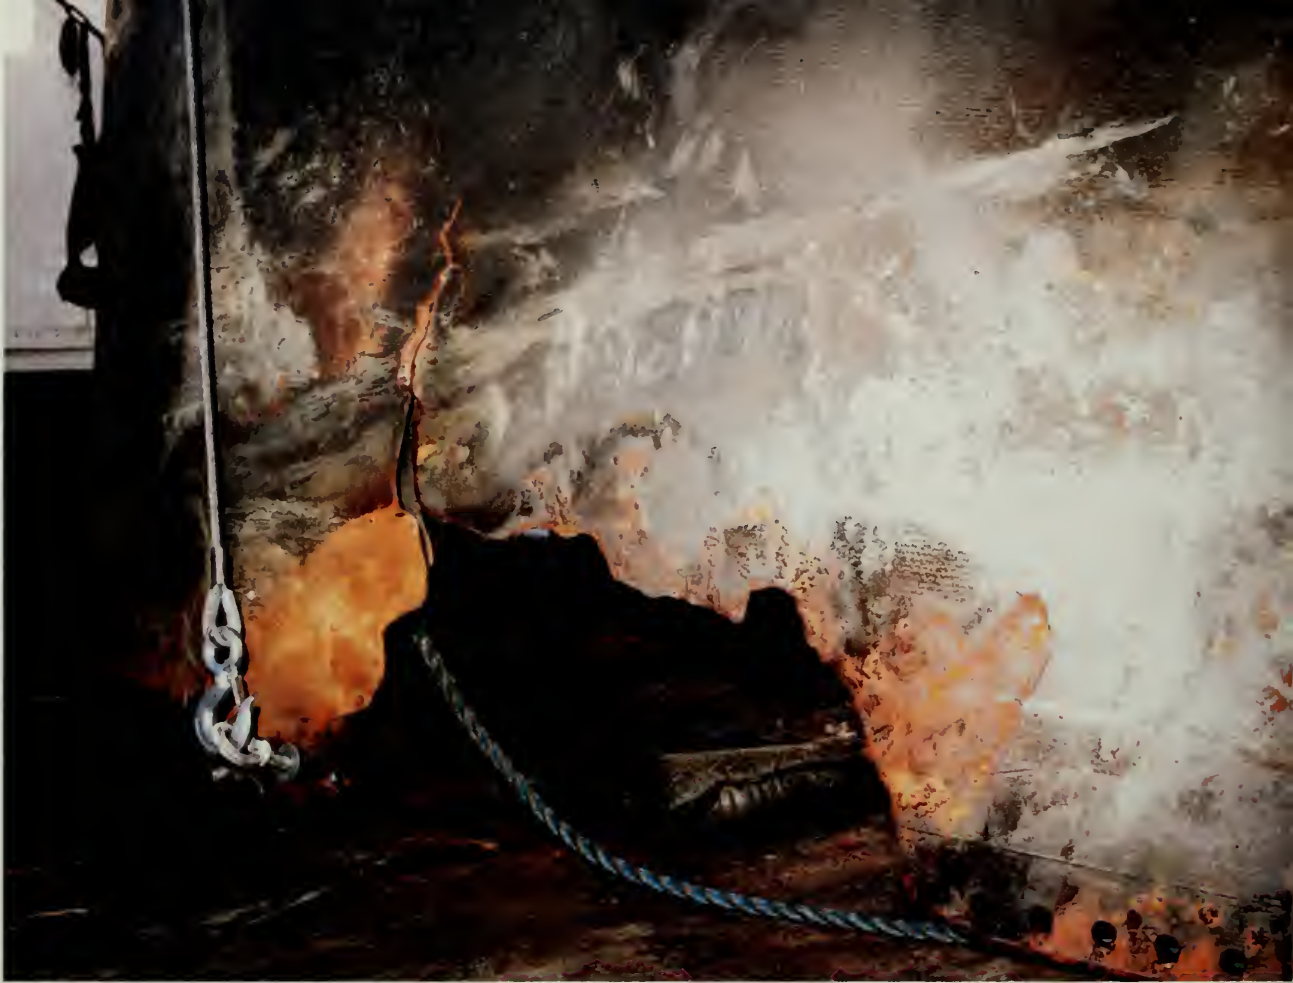
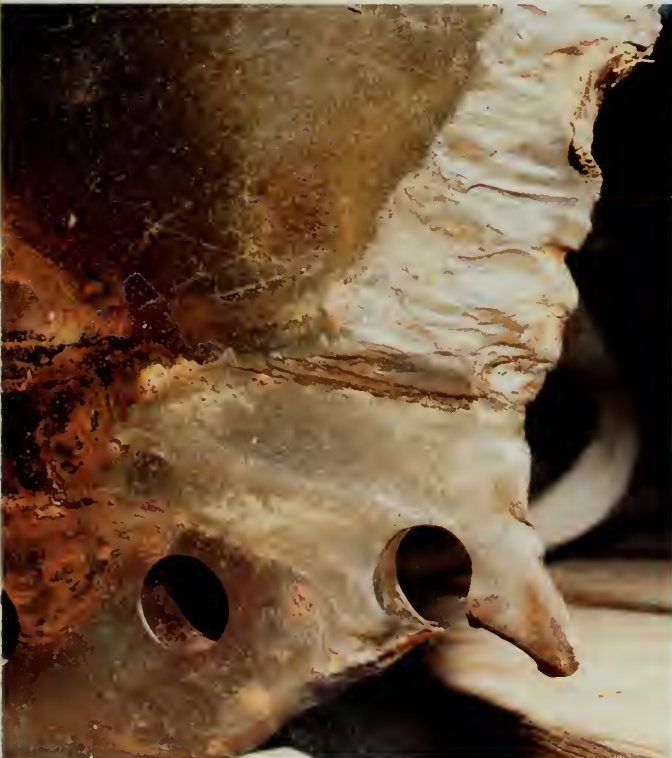
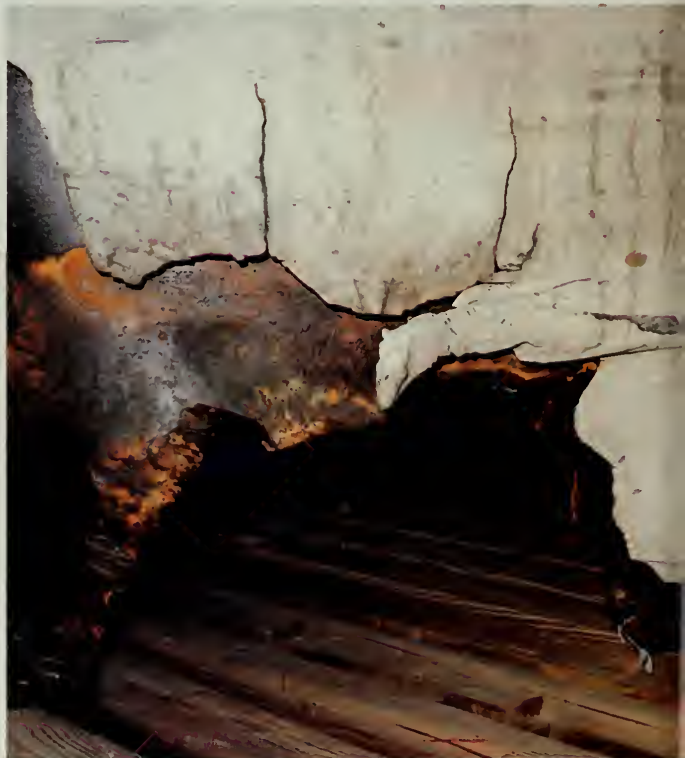
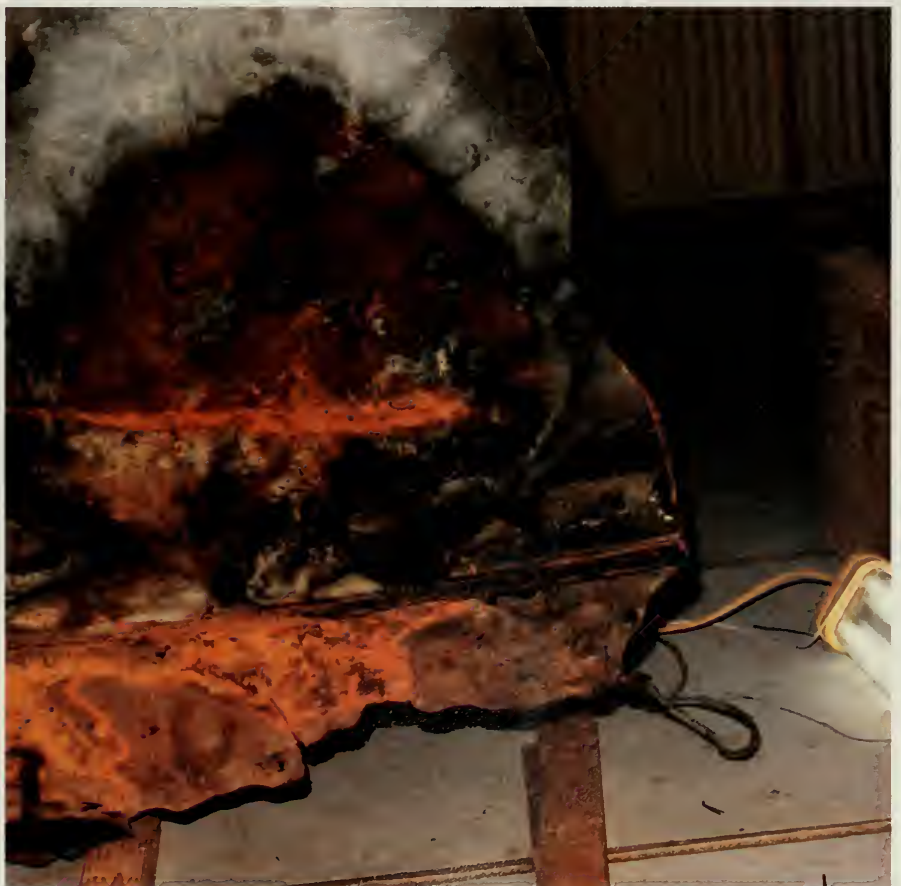
307-degree circumferential position. Although irregular, the hole is roughly rectangular in shape, extending approximately 27 inches circumferentially along the tang (296 to 318 degrees) with total burnout extension approximately 15 inches forward of the tang. At either side in the interior of the hole (photo K) the insulation and steel case material showed evidence of hot gas erosion that beveled these surfaces (indicative of combustion products flowing through the hole from the interior of the Solid Rocket Motor). The top surface of the hole was hardly beveled at all. The

Examined at Kennedy Space Center after their recovery from the ocean, these fragments show the extent of burn through the right hand booster's aft field joint. On the left page are sections of the aft center motor segment above the joint. On the right page are sections (inverted) of the aft motor segment showing burn-hole below the joint (bracket). Except for the interior views on lower left, the camera is viewing the parts from outside the casing.

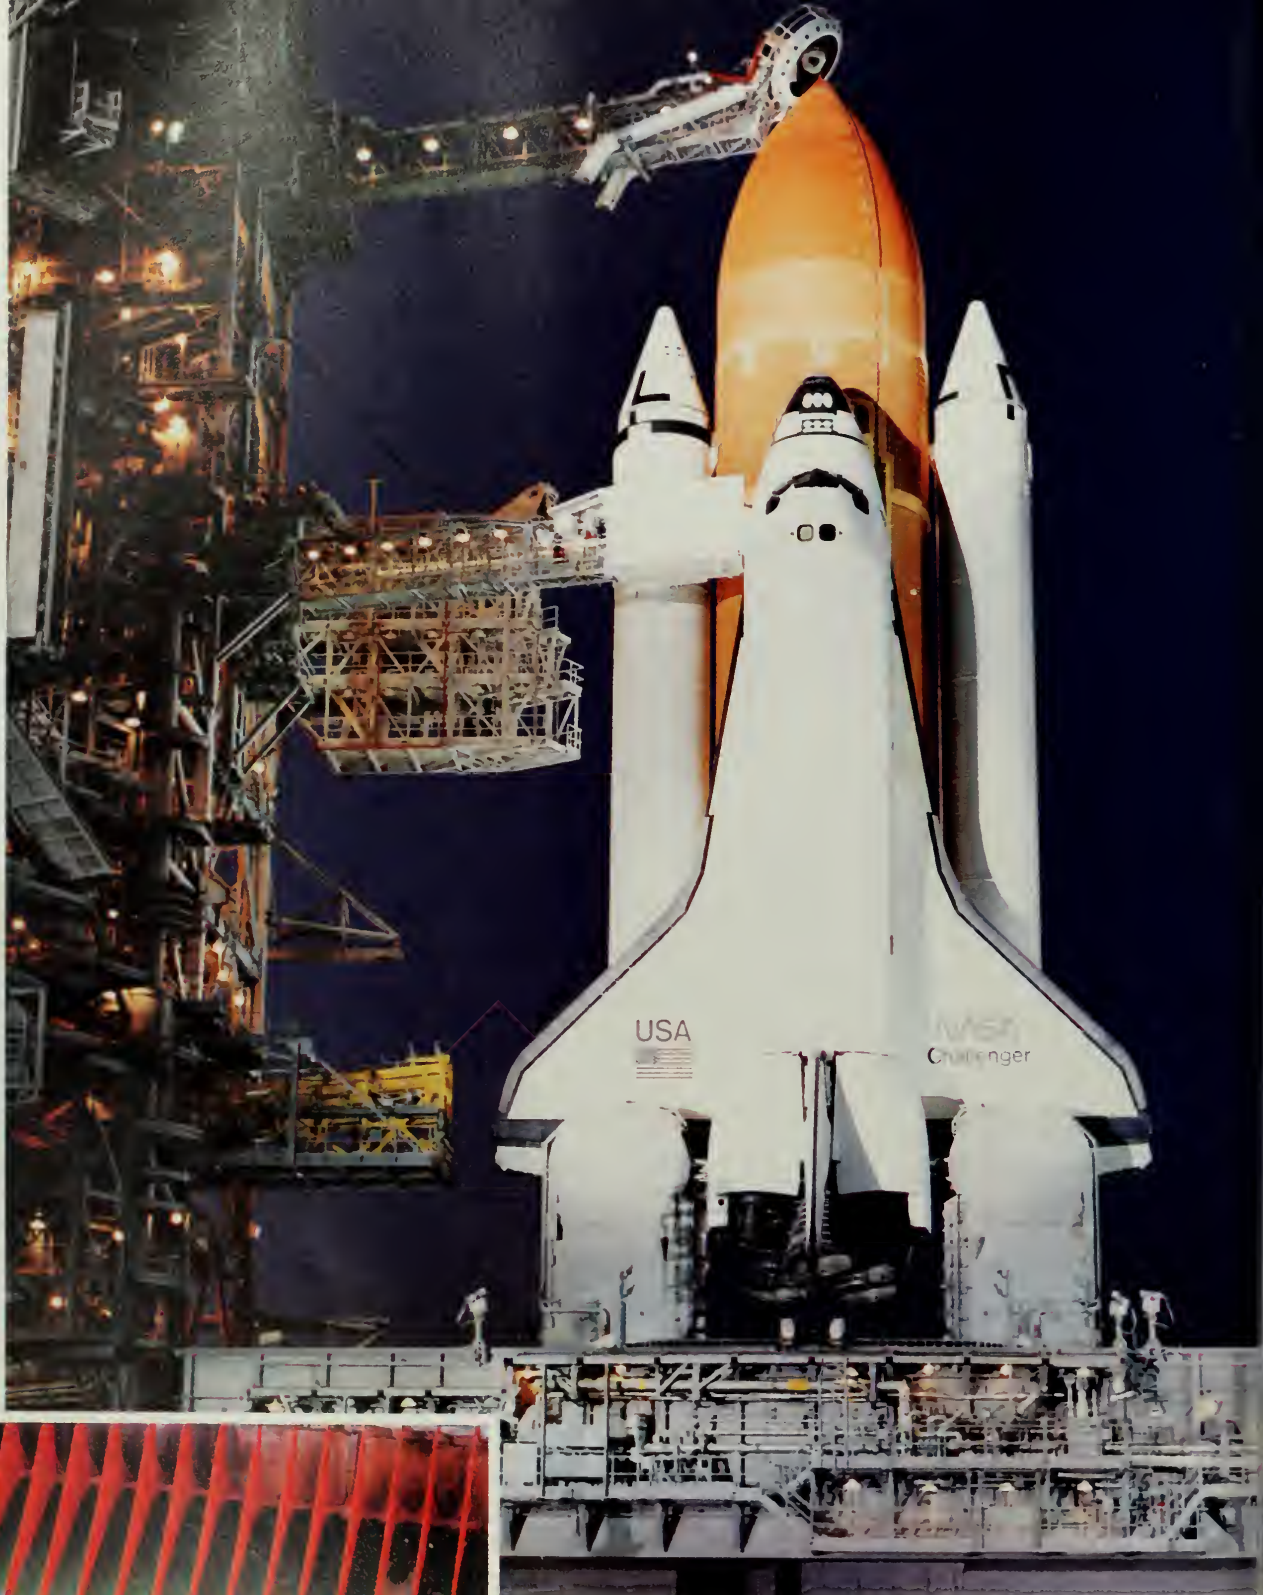
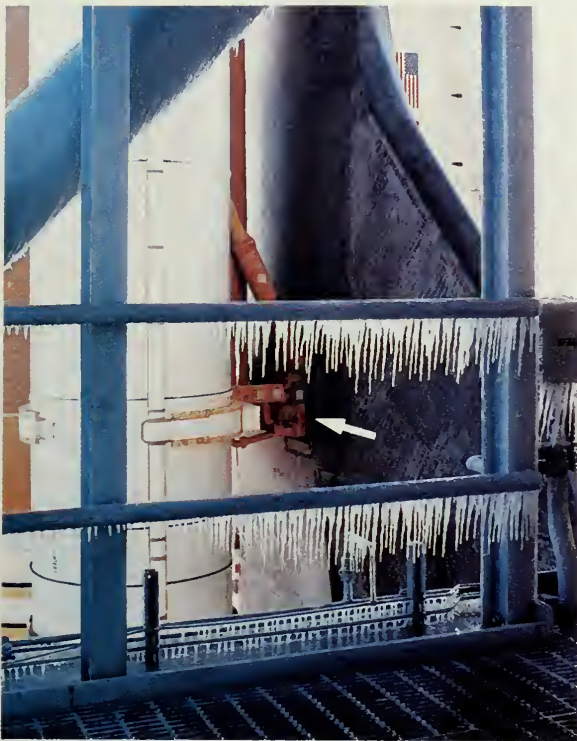
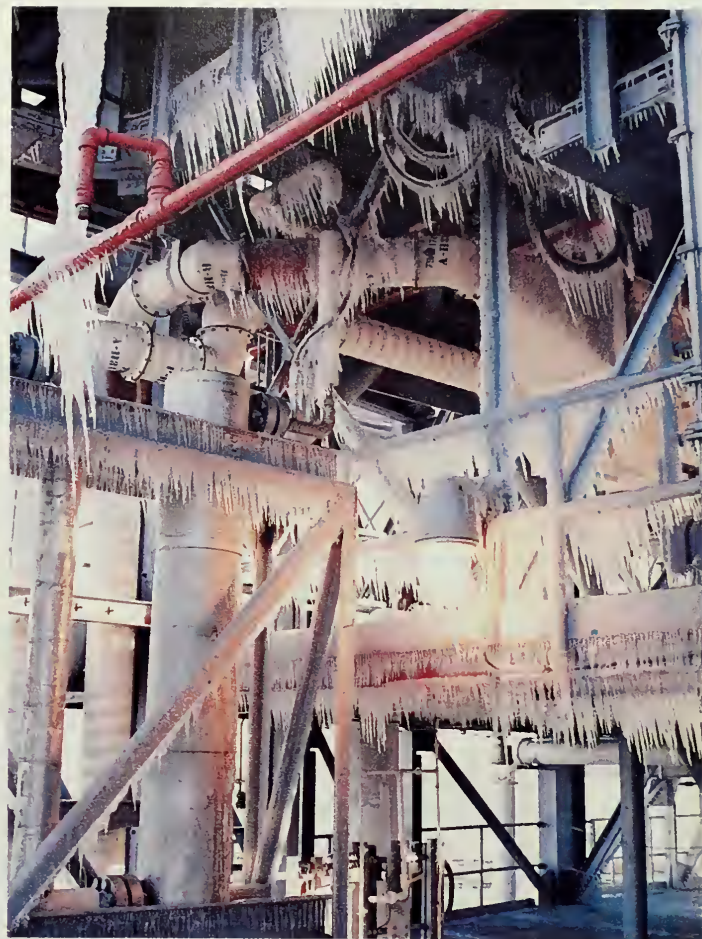
Above, Shuttle 51-L on Kennedy Space Center Pad 39B in the early morning of launch day. Temperatures were well below freezing, as indicated by the lower left photo, which shows thick ice in a water trough despite use of an anti-freeze solution.

Above, foot long icicles on a lower level of the Fixed Service Structure frame the attachment point where the Orbiter is attached to the external tank (arrow). Icing was even more extensive at upper levels of the service structure (upper right and below). At right below is a ground communications box (not used during launch) rendered inoperable by heavy ice.

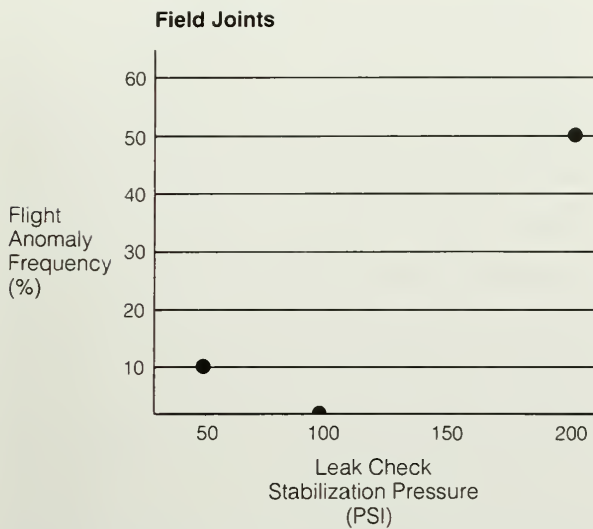
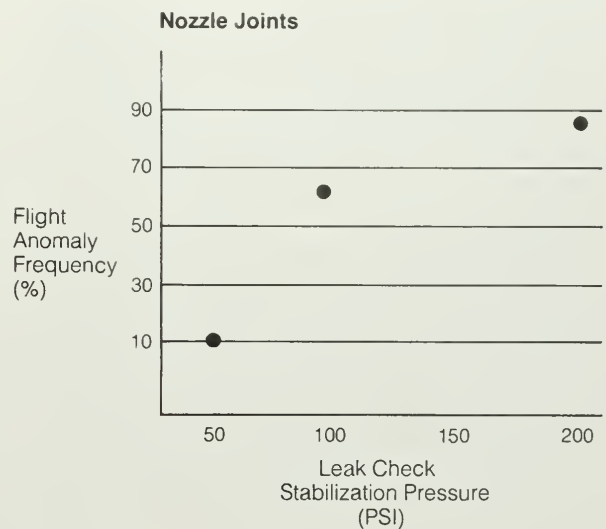
Graphs depict flight anomaly frequency for both field and nozzle joint of solid motors for a variety of leak check pressures Figure 3

This hypothesis that O-ring erosion is related to putty blow holes is substantiated by the leak check history (Figure 3). Prior to January, 1984, and STS 41-B, when the leak check pressure was

The trends of flight anomalies in relation to leak check stabilization pressure are illustrated for the field joint and the nozzle joint in Figure 3, on page 133. While the data point concerning the 100 pound per square inch field joint leak check is not conclusive since it is based on only two flights, the trend is apparent.

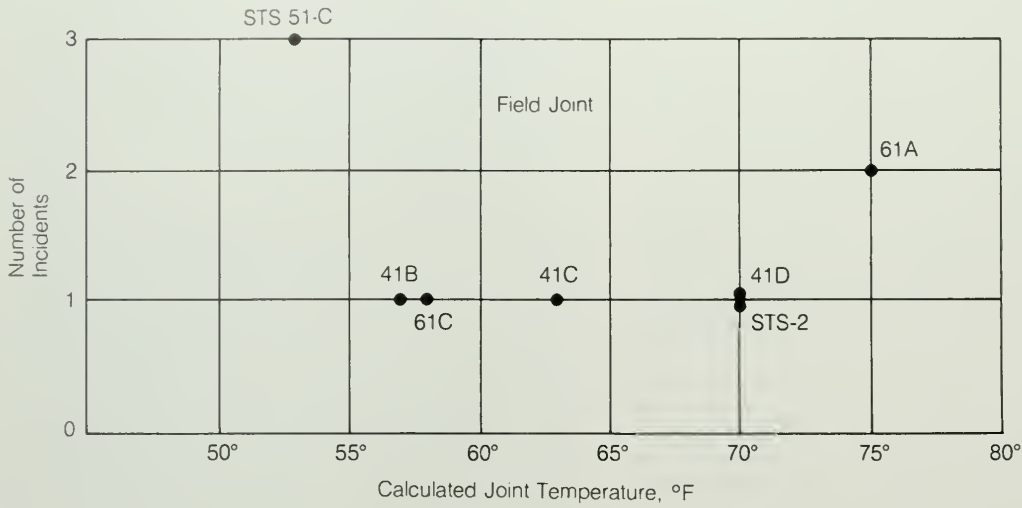
cy of occurrence based on all flights (Figure 6). In such a comparison, there is nothing irregular in the distribution of O-ring “distress” over the spectrum of joint temperatures at launch between 53 degrees Fahrenheit and 75 degrees Fahrenheit. When the entire history of flight experience is considered, including “normal” flights with no erosion or blow-by, the comparison is substantially different (Figure 7).

Figure 6  
Plot of flights with incidents of O-ring thermal distress as function of temperature

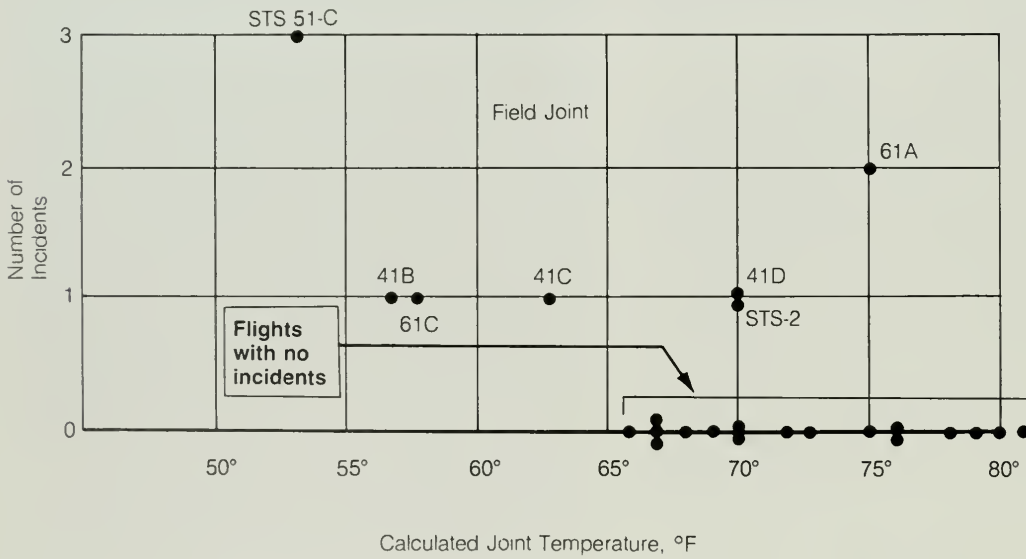
Figure 7  
Plot of flights with and without incidents of O-ring thermal distress

NOTE: Thermal distress defined as O-ring erosion, blow-by, or excessive heating

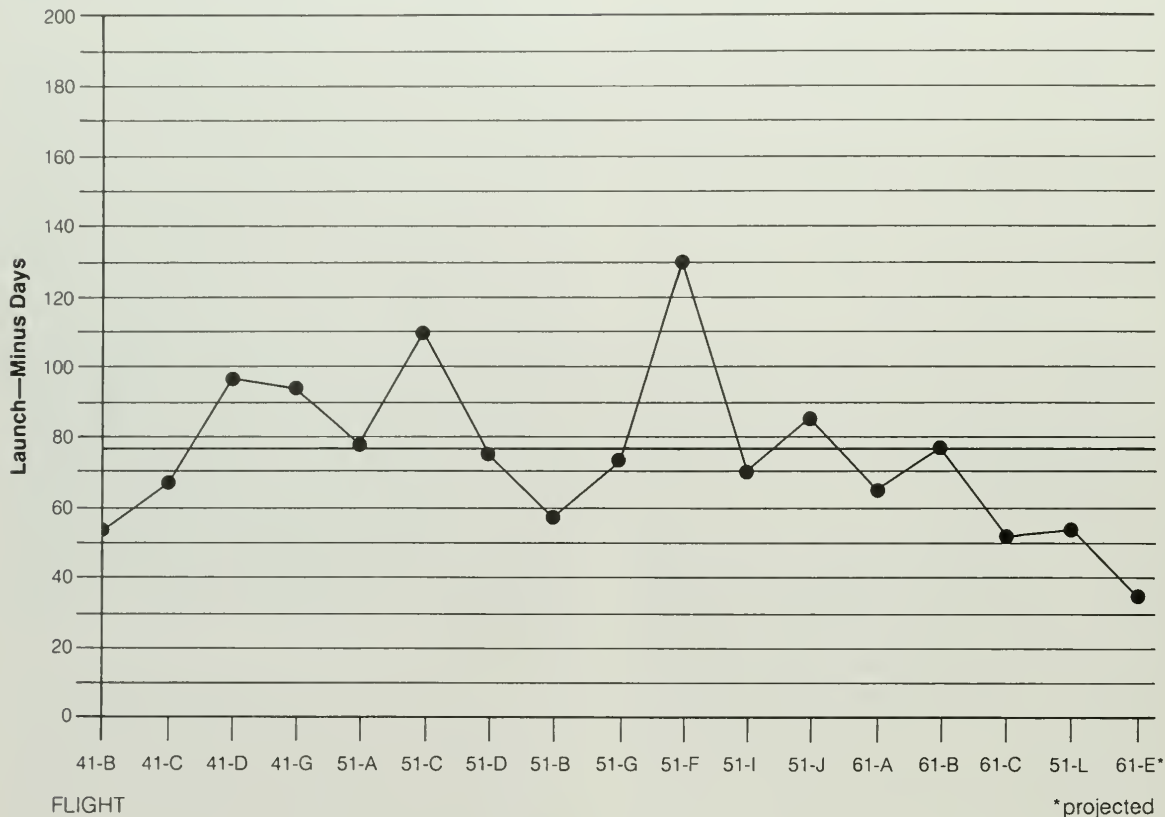
When Shuttle Mission Simulator Training Began in  
Comparison With the Normal Launch-minus-77-Days  
Training Start Date

Graph depicts beginning of simulator training for Shuttle crews in days before launch for missions 41-B through 61-E.

behind. An assessment of the system's overall performance is best made by studying the process at the end of the production chain: crew training. Analysis of training schedules for previous flights and projected training schedules for flights in the spring and summer of 1986 reveals a clear trend: less and less time was going to be available for crew members to accomplish their required training. (See the Shuttle mission simulator training chart.)

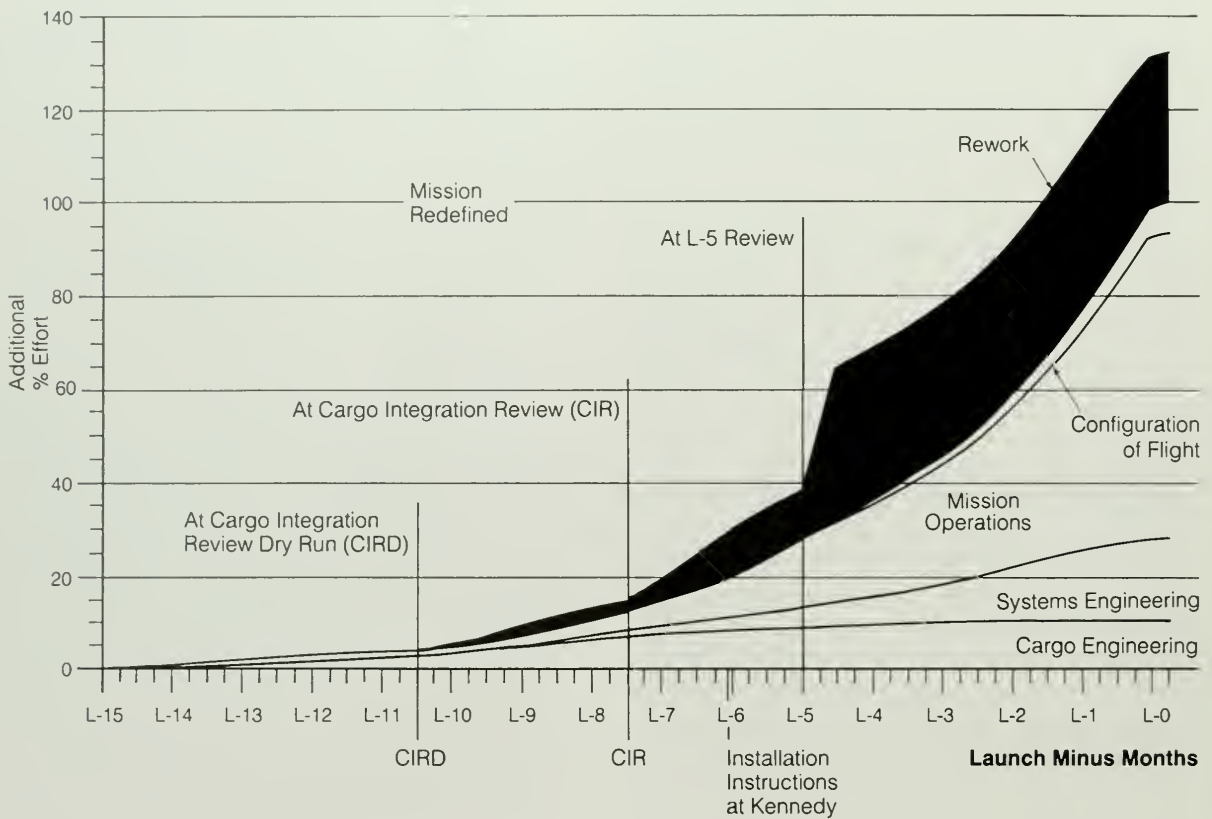
**Impact of Manifest Changes  
on Workload at Johnson Space Center**

Graph shows that changes to the payload manifest for Shuttle missions can boost Johnson Space Center workload as much as 130 percent

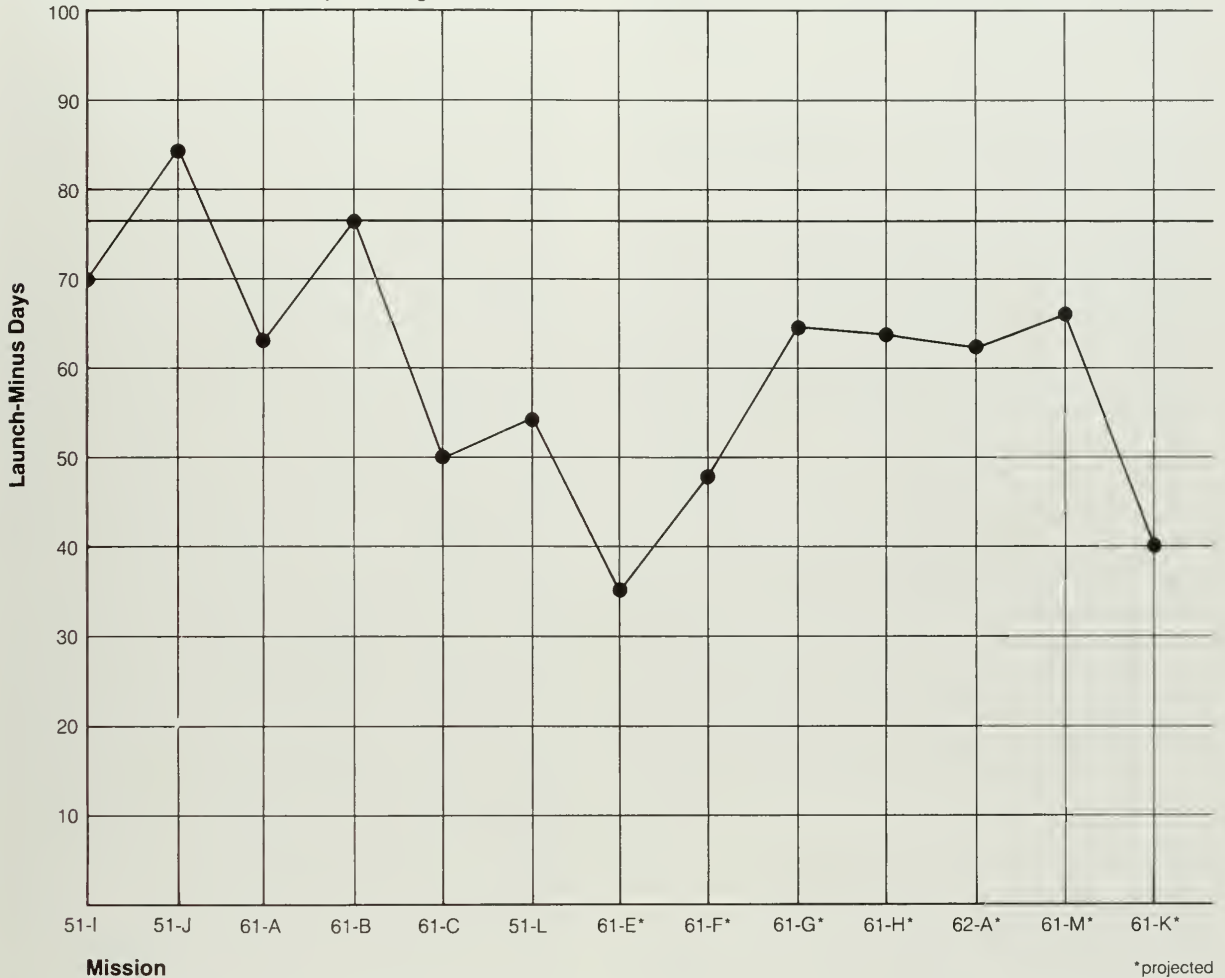
When Shuttle Simulator Training Began in Comparison with the Normal Launch-Minus-77-Days Training Start Date

Graph depicts beginning of simulator training for Shuttle crews in days before launch for missions 51-L through 61-K. Launch minus 77 days is normal training date start.

Again, a "single" late change affected at least two flights very late in the planning and preparation cycles.
